WEATHERING OF ARCHITECTURAL METALS -THE ULTIMATE DICHOTOMY

By David L. Hunt

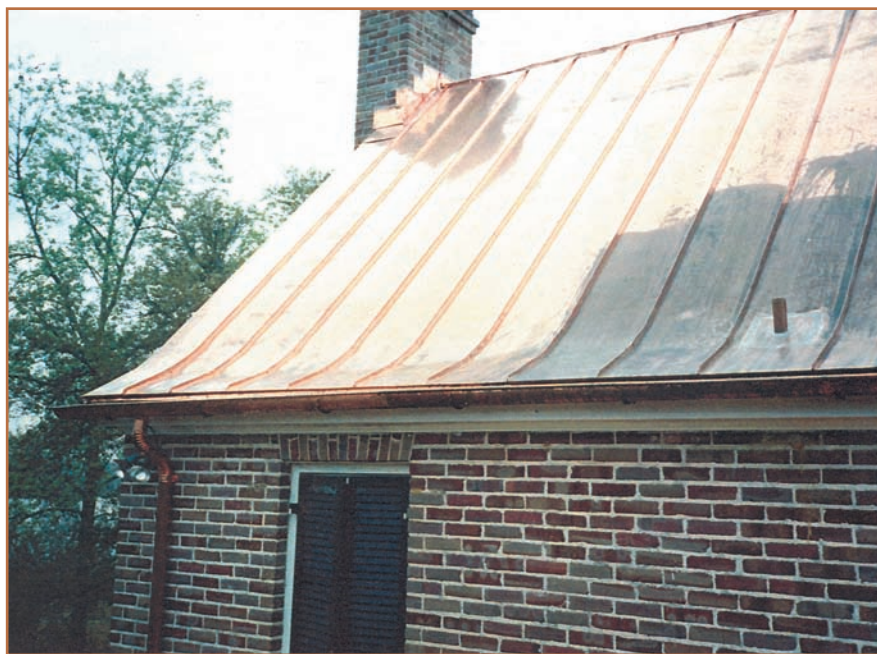
Photo 1: This Maryland residence shows normal but unusual weathering.

The Maryland residence shown in *Photograph 1* is an excellent example of normal but very unusual weathering. By knowing and understanding the factors that can influence early coloration and how long it takes for a mature patina to develop, a roof consultant should have been able to explain what was happening and to persuade the owner and architect to give Mother Nature more time. However, the “experts” who inspected the roof were unable to offer an explanation as to why the roof appeared as it did.

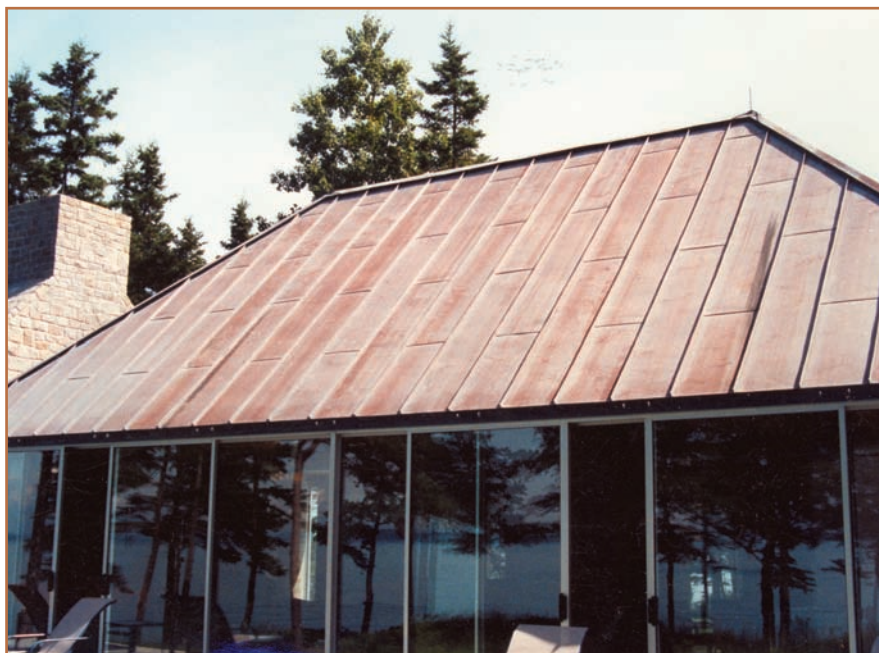
Photo 2: A new copper roof on a home in Charleston, SC, showed uneven weathering after the contractor “neutralized and washed down” the copper to remove residual flux.

Photograph 2 shows a new copper roof on a home near

Charleston, South Carolina. After soldering the vent stack flashing in place, the contractor “neutralized and washed-down” the copper to remove residual flux. In doing so the contractor also removed the anti-stain compound and residual lubricants from a small area. The cleaned area began to weather much quicker than the surrounding uncleaned copper – literally overnight. Again, the homeowner was displeased and questioned the quality of materials and workmanship.

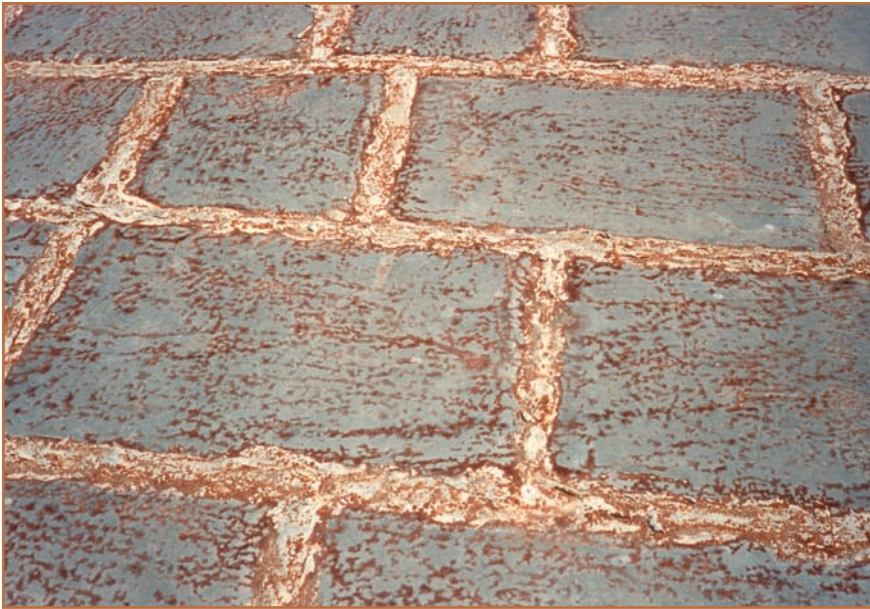
Photo 3: The owner of this roof off the coast of Maine complained that the lead was coming off his lead-coated copper. In actuality, “red lead” patina was forming.

As environmental awareness grew in the latter part of the century, the level of atmospheric sulphur (and other pollutants) was reduced. Early in 1992, Revere was contacted by a New England architect regarding an LCC roof on a residence on an island off the coast of Maine. The owner of the home was complaining that "the lead is coming off the lead-coated copper" (See *Photograph 3*).

Inspection and tests showed that the lead was not coming off but that a "red lead" patina (Pb_3O_4) was forming. *Figures 1 and 2* are pourbaix diagrams developed by an MIT metallurgist retained by the homeowner to provide an explanation as to why the

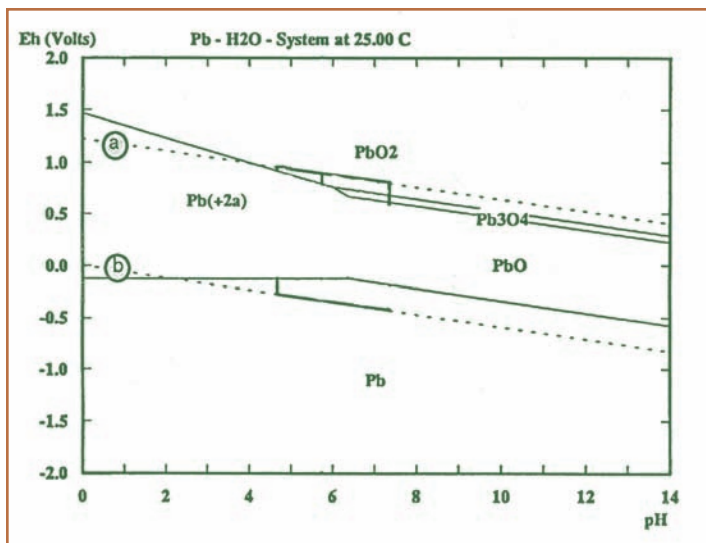
Figure 1

The diagrams show the "products of corrosion" for lead + water and lead + water + sulphur. These are for pure conditions – no other elements. Obviously, this is not the state in nature, but they do show that red lead can develop naturally.

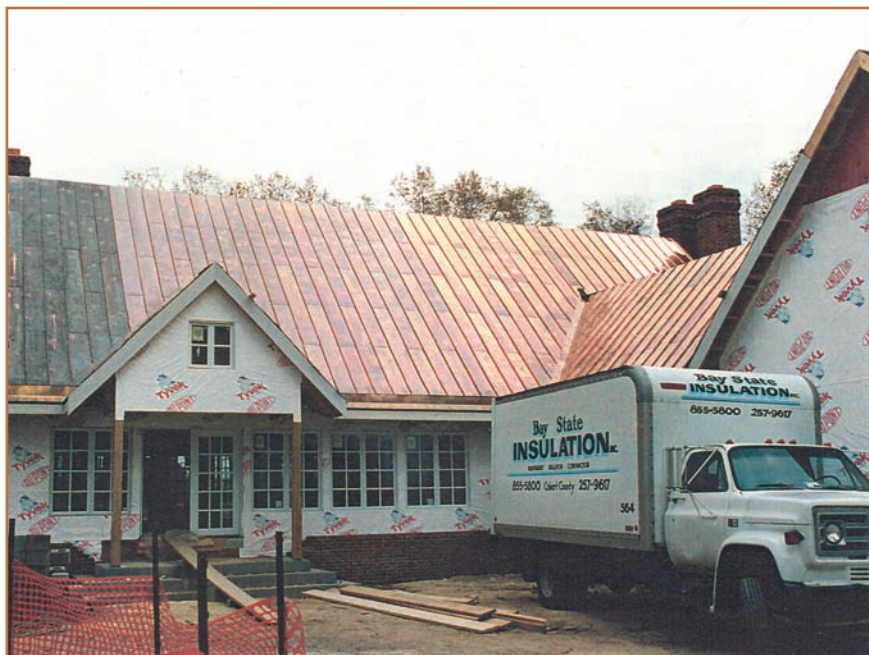
Photo 4: Red lead on a locked and soldered flat-seam, lead-coated copper roof.

Subsequently, red lead was seen on a locked and soldered flat-seam LCC roof of a residence near Myrtle Beach, South Carolina. As shown in *Photograph 4*, the red is not only on the LCC, but also on the solder.
