Weathering of Architectural Copper

by David Hunt

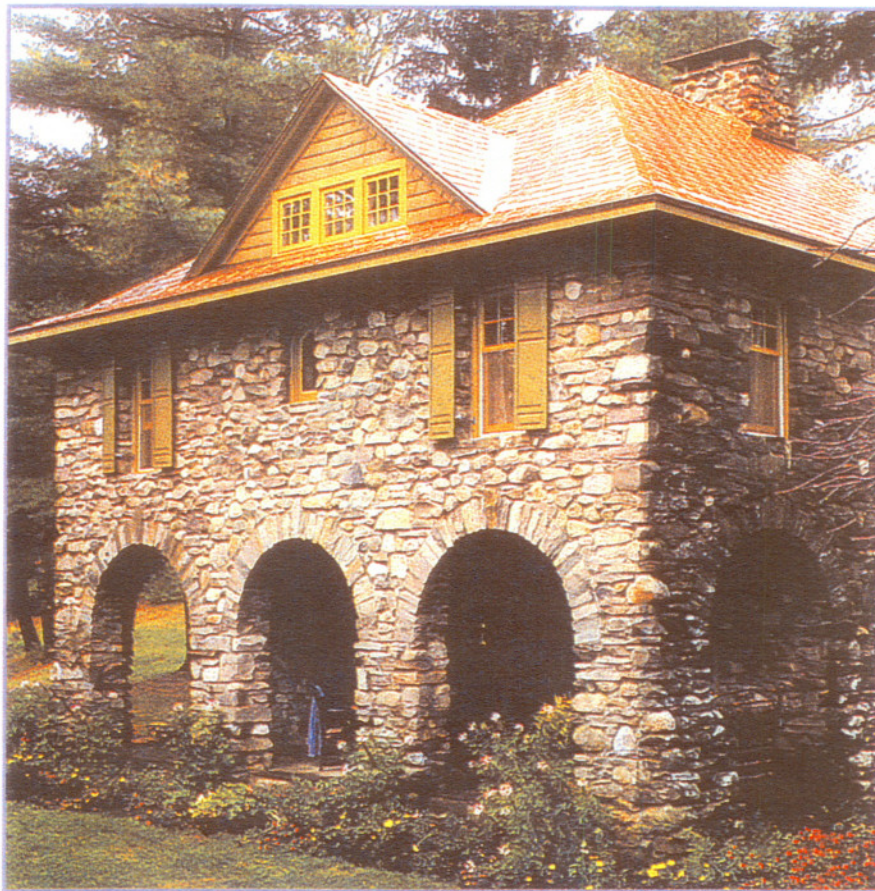
In its earliest stages of weathering, copper can exhibit shocking colors and/or patterns.

In its earliest stages of weathering, copper can exhibit shocking colors and/or patterns. In extreme cases, it can change from bright and shiny to mottled and dark literally overnight. Although unusual, this is natural.

The first phase of weathering is the formation of extremely thin oxide films on copper. These are so thin that rainbow-hued interference colors are often seen. Although blacks and purples are most common, yellows, blues, greens, pinks, oranges and/or reds also can develop. With time and continued exposure, the oxide films build and thicken. With this, the interference colors fade and are replaced with more uniform russets or browns.

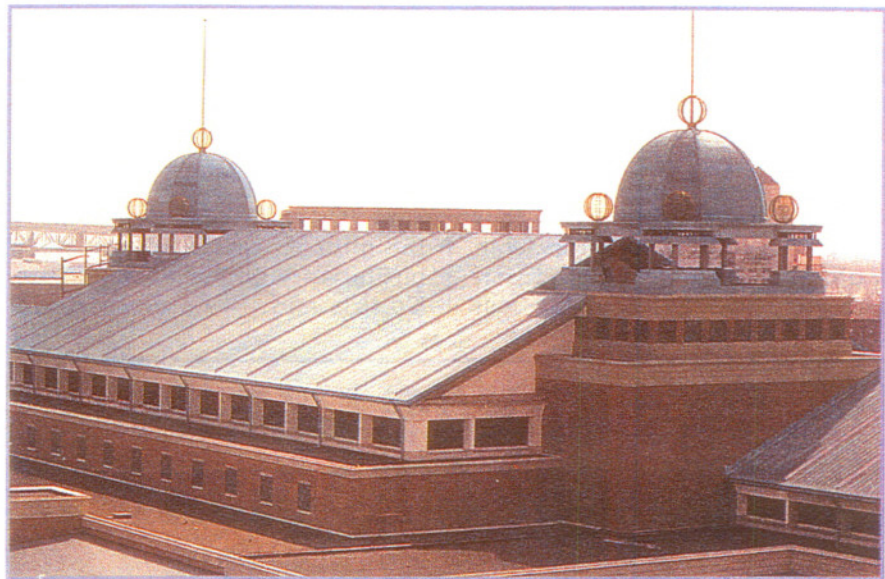
Seen here is Harrah's Casino in New Orleans. The copper sheet used for this insulation had been treated under controlled processing to create the surface patina – without the natural 20-year-or-so wait.
